Monitoring of Marine INNS Using Submerged Settlement Panels

Stranraer Marina and Portpatrick Harbour

May to September 2018

Solway Firth Partnership September 2018

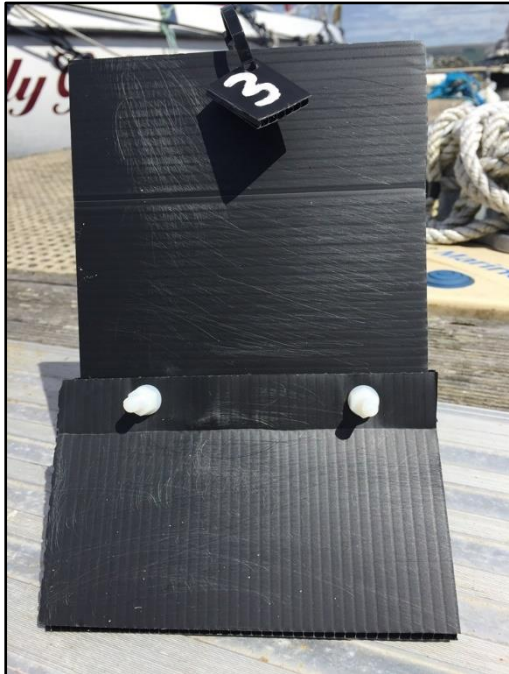
Photo 1– Complex Correx panel structure

Six settlement panels (Photo 1), were attached to pontoons within Stranraer Marina on 21st May 2018 (Figure 1). A further two panels, at separate locations were attached to the RNLI pontoon at Portpatrick Harbour (Figure 2) on the same day.

Continued awareness of INNS gained from the use of the panels and the rapid site assessments will allow for improved biosecurity control of invasives at the two locations. It is recommended the use of the current 3D scratched surface panel design is continued, as this seems to encourage a representative level of growth.

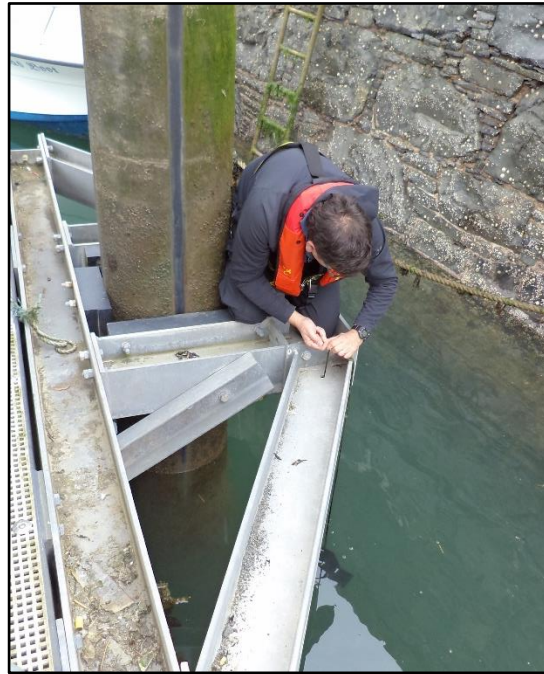
Photo 2 - Attaching panels

The panels were attached to the underside of the pontoons (Photos 2) and submerged to around one metre depth using strong paracord and weighed down with 6 oz fishing weights (Photo 3).

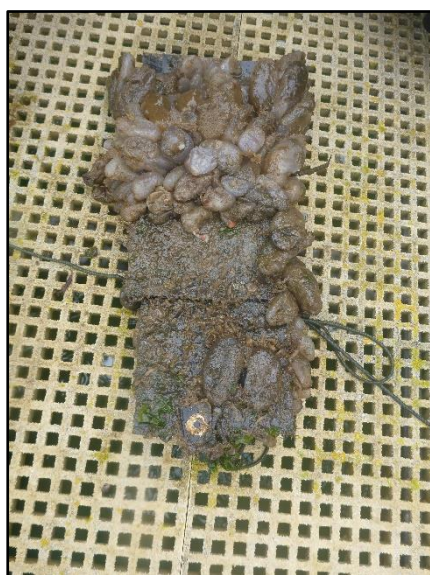
Photo 4 – Panel with growth

After seventeen weeks, at the end of summer (20 September 2018) the panels at Stranraer and Portpatrick were collected, photographed (Photos 4 and 5), scored for percentage cover of surface species and then discarded. Mobile organisms, including barnacle cyprids and crabs were counted individually. Each side of each panel was assessed individually for species present and percentage cover.

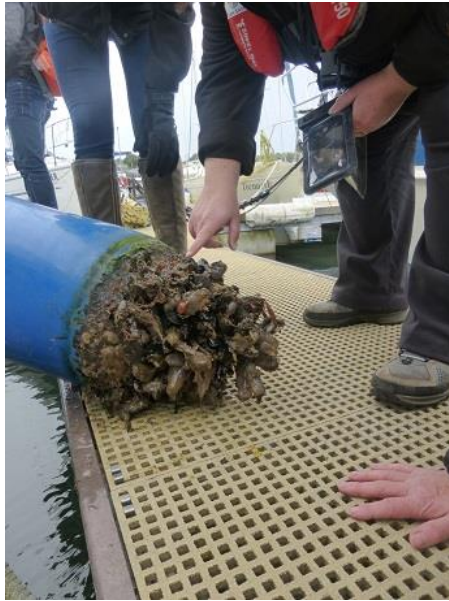
Photo 6 – Underside of a buoy

In addition, other species present on buoys and on the underside of the pontoon were recorded (Photos 6 and 7).

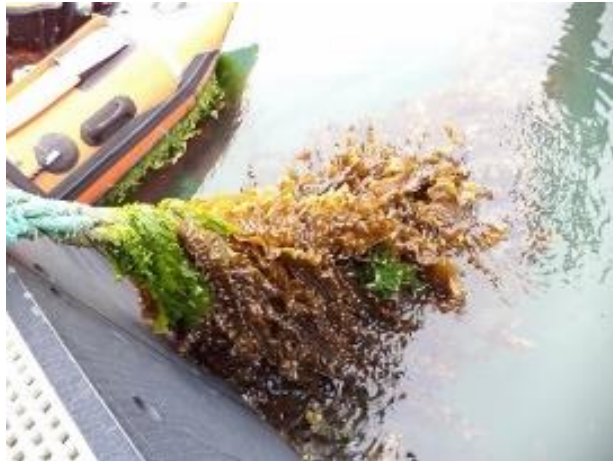
Photo 7 – Rope pulled up to inspect

A Rapid Assessment Survey (RAS) was also conducted at Stranraer, looking at the pontoons, buoys and vessels present. The invasive Japanese skeleton shrimp, *Caprella mutica* was recorded during the RAS. An assessment was not conducted at Portpatrick, as the floating pontoon where the panels were anchored was relatively small with no buoys available for inspection. A large mooring rope was lifted partway from the water but no invasive species were immediately visible (Photo 7).

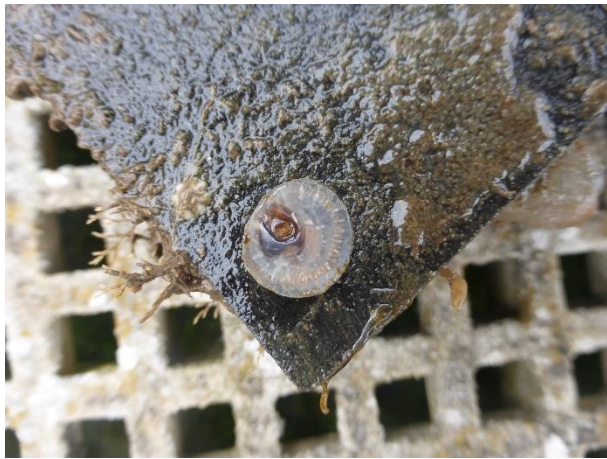
Photo 6 - Saddle oyster

Stranraer panels also hosted species that although known to be present, had not been found in previous monitoring surveys. These species included: the saddle oyster, *Anomia ephippium* (Photo 8) the cockle, *Cerastoderma edule* and the long-clawed porcelain crab, *Pisidia longicornis* (Photo 9).
