MARINE INVASIVE NON-NATIVE SPECIES ADVICE NOTE

Holyhead marina incident and potential spread of the marine invasive non-native species *Didemnum vexillum*

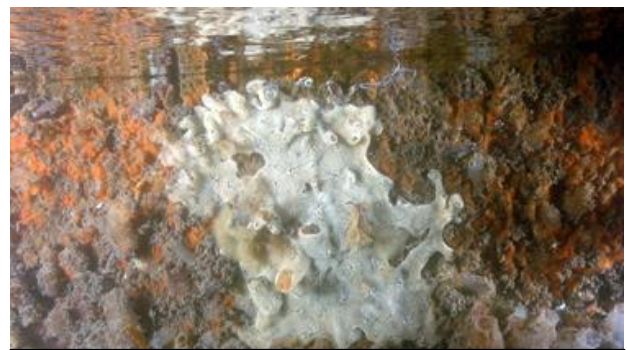
Prior to storm Emma, *D. vex* was being contained in the marina after being discovered living on the submerged artificial structures, commonly found on the floating pontoons, ropes and chains. (Fig 1-2). The resin surface of the floating pontoons provided a suitable area for *D. vex* to live.

Fig 1. *D. vex* on submerged pontoon surface in Holyhead

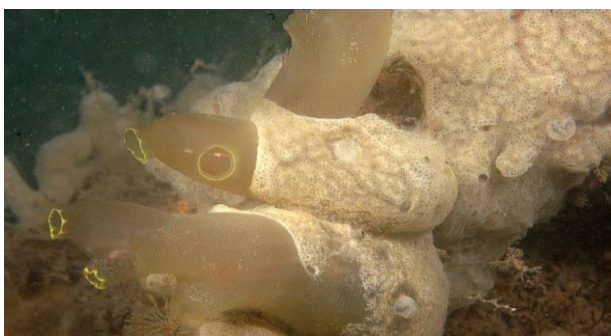
Fig 2. *D. vex* growing on native species in Holyhead

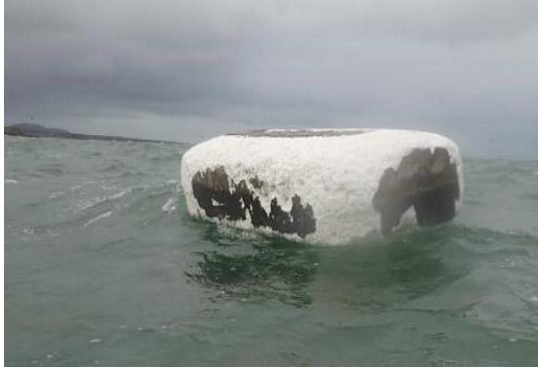
Evidence suggests that debris has the potential to spread quite far from Holyhead. Remains of a floating pontoon with resin coating has been recorded approx. 37km away from the marina (Fig. 3).

Fig 3. Remains of floating pontoon with surface resin (Photo credit: Ashley Williams)

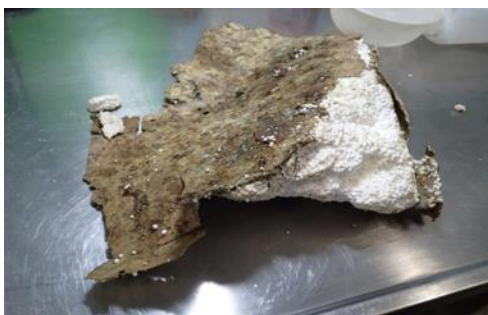
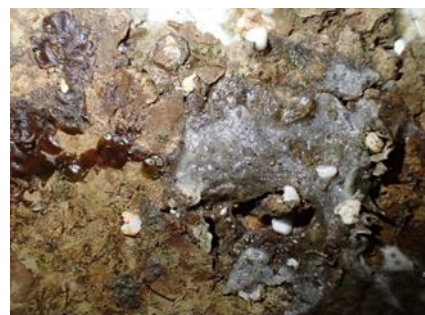
Fig 4-5 Specimens in the fouling community appeared similar to *D. vex* but had dried out too much to confidently identify.

Where it is possible and safe to do so, we suggest any debris found, an example is provided at figure 4-5 below, is moved above the high tide line to prevent it from returning to the sea and help remove the risk of *D. vex* spreading.

We suggest also that any locations where fouled debris has been collected from be revisited later in the year to check for the presence of *D. vex*.
